AIRCRAFT ACCIDENT
N800X (342)
25 FEB 1966

AIRCRAFT ACCIDENT INVESTIGATION N800X (342)

AIRCRAFT ACCIDENT ARTICLE 342 (N800X)

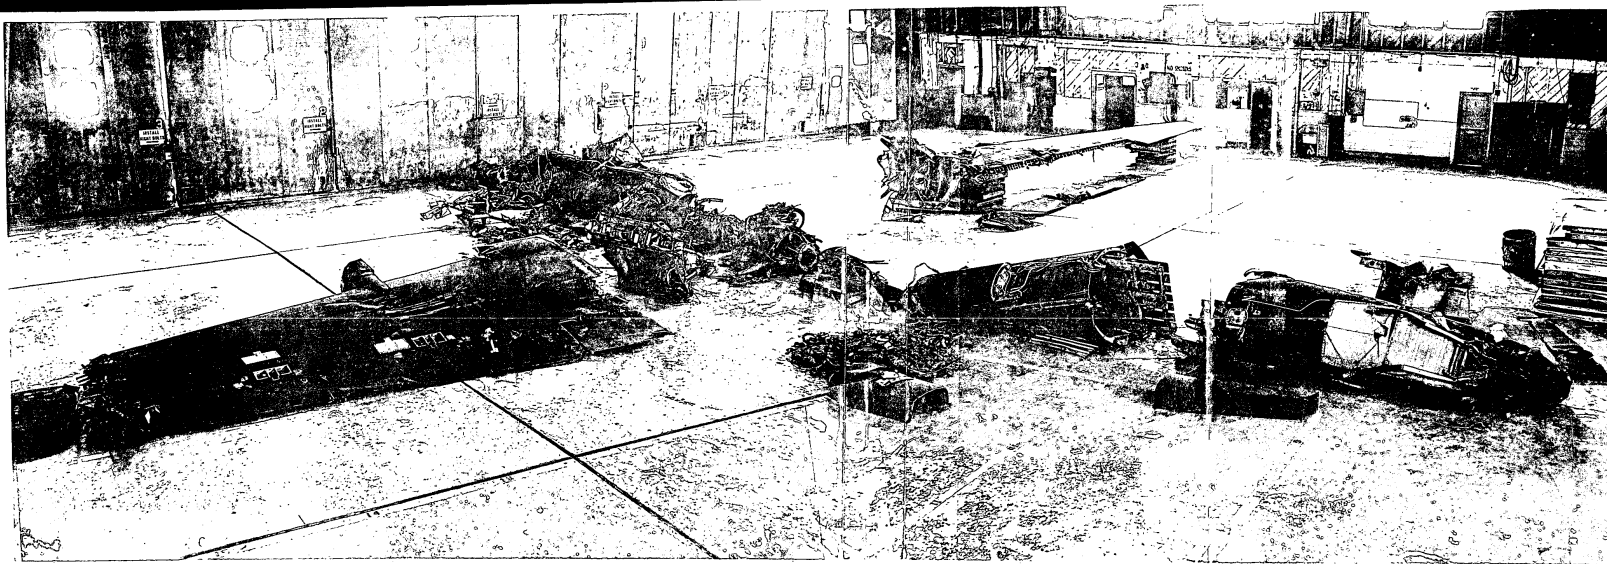
GENERAL VIEW OF COMPONENTS OF NS00X (342) RECOVERED FROM THE FIELD.
THE FORWARD FUSELAGE, AFT FUSELAGE AND TAIL SURFACES WERE PARTLY
DISMANTLED FOR TRANSPORTATION PURPOSES AS WAS THE RIGHT WING FLAP.
THE LEFT WING OUTER SECTION WAS BROKEN WHEN DROPPED FROM HELICOPTER.

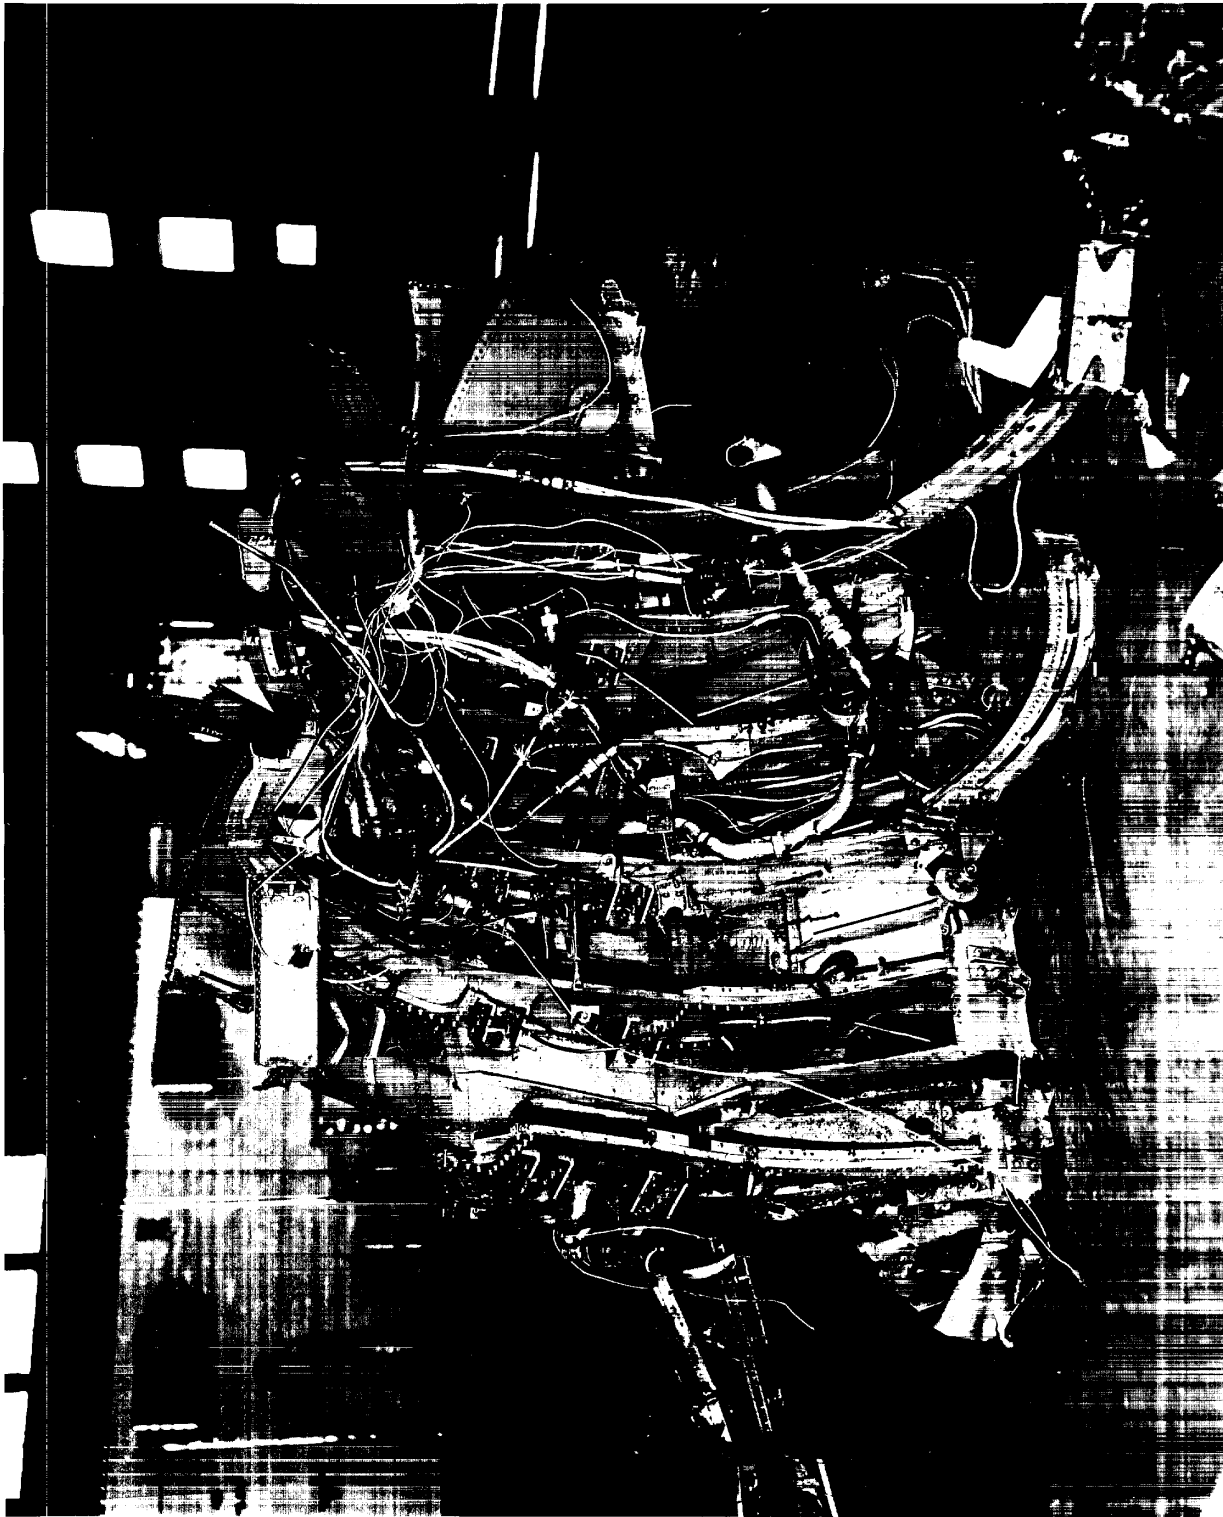
PART OF LEFT SIDE OF FUSELAGE WITH FIRST LEFT WING RIB
SHWOING THE LEFT BALL BAT SUPPORT STRUCTURE BROKEN (ARROWS).

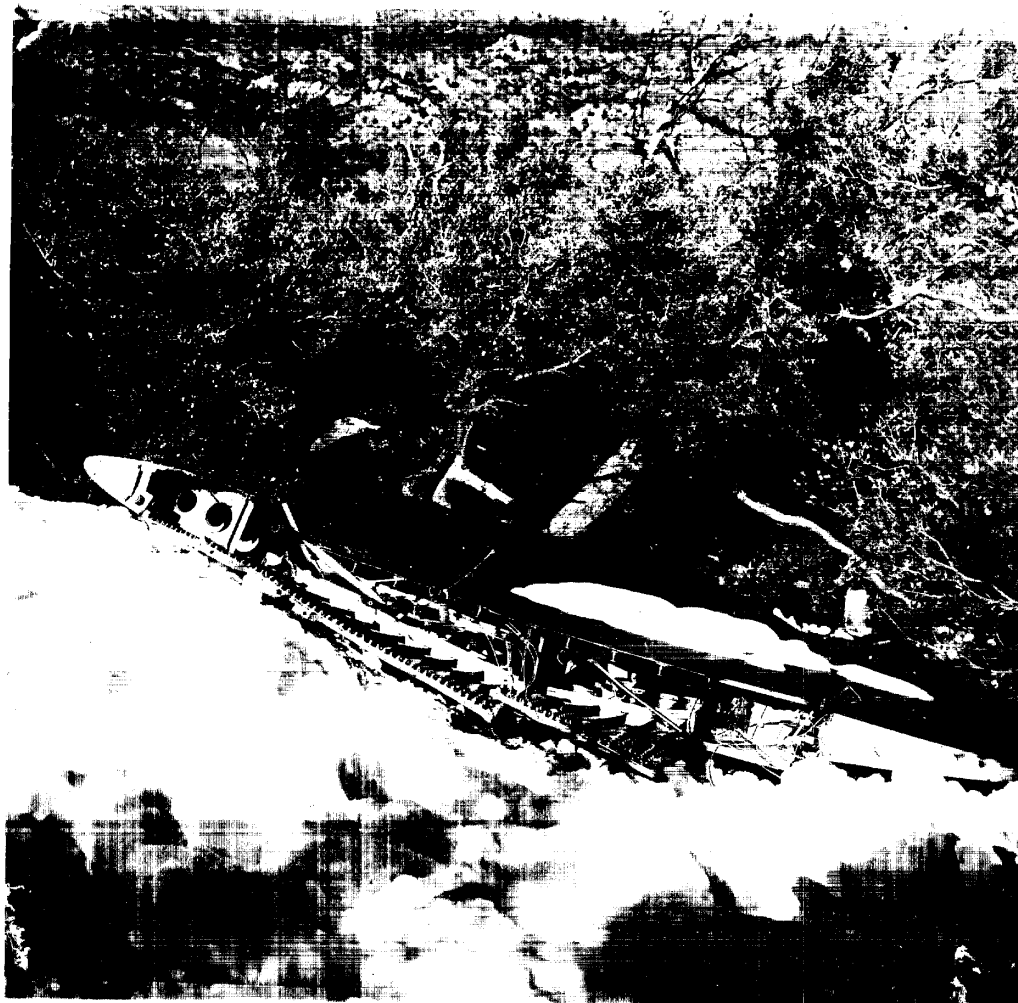
4. The left wing failed at the root at the same time as aileron was being applied, (left aileron down). This application of aileron, at the same time as positive "G" was being exerted, applied a twisting moment to the wing at the same time as it was subjected to a bending moment at a high airspeed. The design characteristics of the wing are such that there is an aerodynamic tendency for it to twist leading edge up about the flexural axis. Downgoing aileron exerted an opposing twist and the resultant effect was that an additional up load was placed on the outer wing causing it to bend upwards and thus produce a levering moment about the root attachment which was the area of the initial structural failure.

5. The location of the fuel at the time of the accident was in the sump and the auxilliary wing tanks, the fuel in the main tanks being exhausted. This placed the weight of the fuel mainly inboard on the wings, thus allowing the outer wing to bend further upwards, adding to the unfavorable wing bending moment exerted by the aileron and "G" forces.

LEFT WING IN THE FIELD (UPSIDE DOWN) SHOWING THE
PRIMARY STRUCTURAL FAILURE POINT AT THE WING ROOT.

1. The "G" limitations as indicated by the flight strength diagrams in the pilots handbook be reduced when a rolling maneuver is being executed, particularly at higher indicated airspeeds.

2. The fuel placement not to be such that a condition is arrived at whereby the auxilliary tanks are full and the main tanks empty.

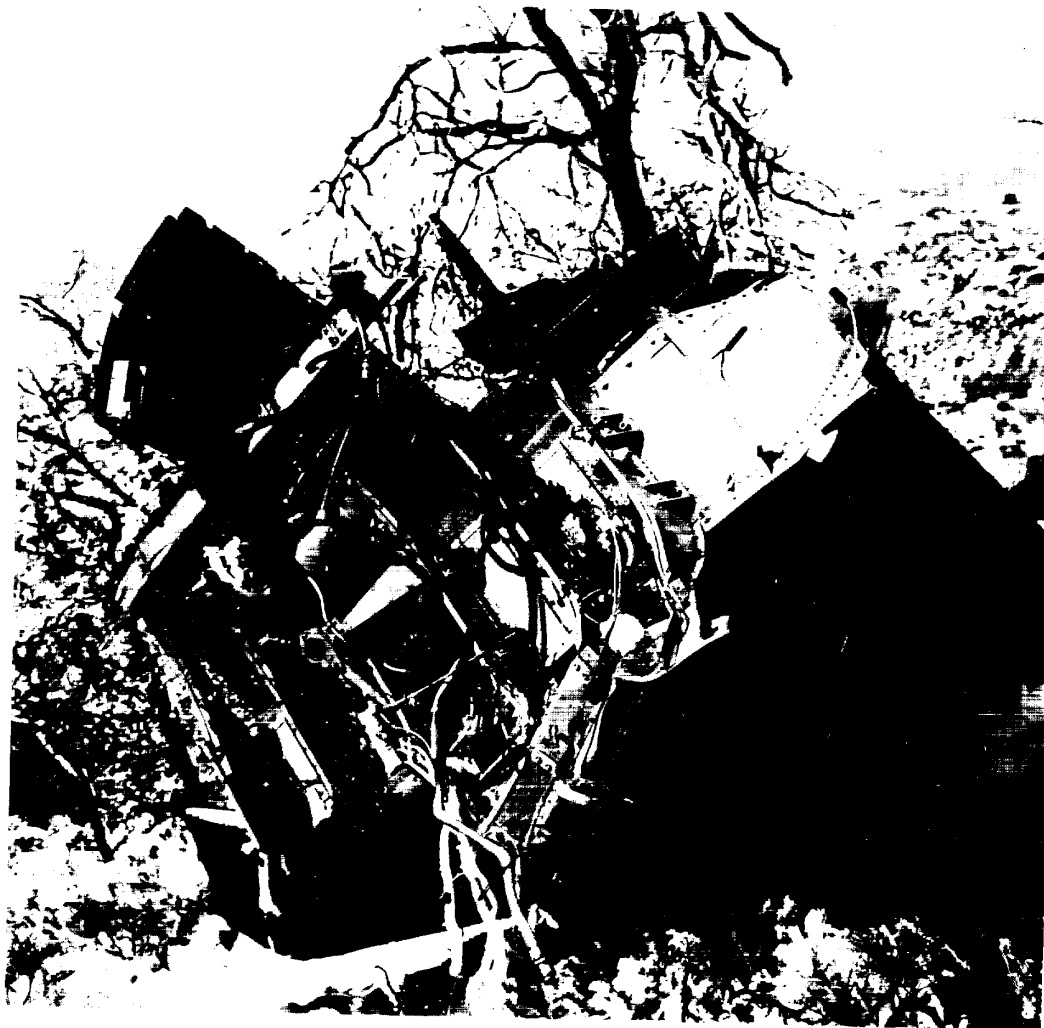
RIGHT WING SHOWING PORTION OF FUSELAGE ATTACHED

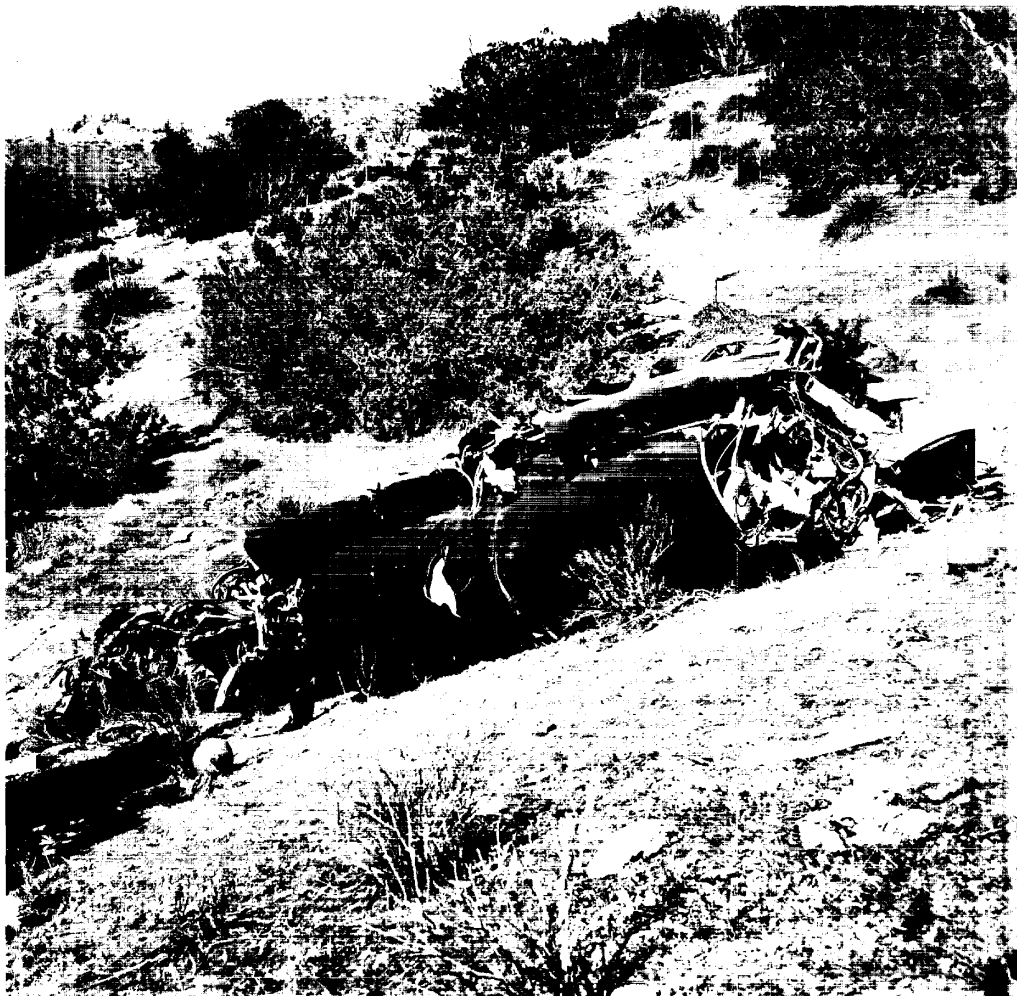
FORWARD FUSELAGE IN THE FIELD. LANDED ON THE RIGHT SIDE,
ALMOST FLAT, BOUNCED OVER ONTO THE LEFT SIDE.

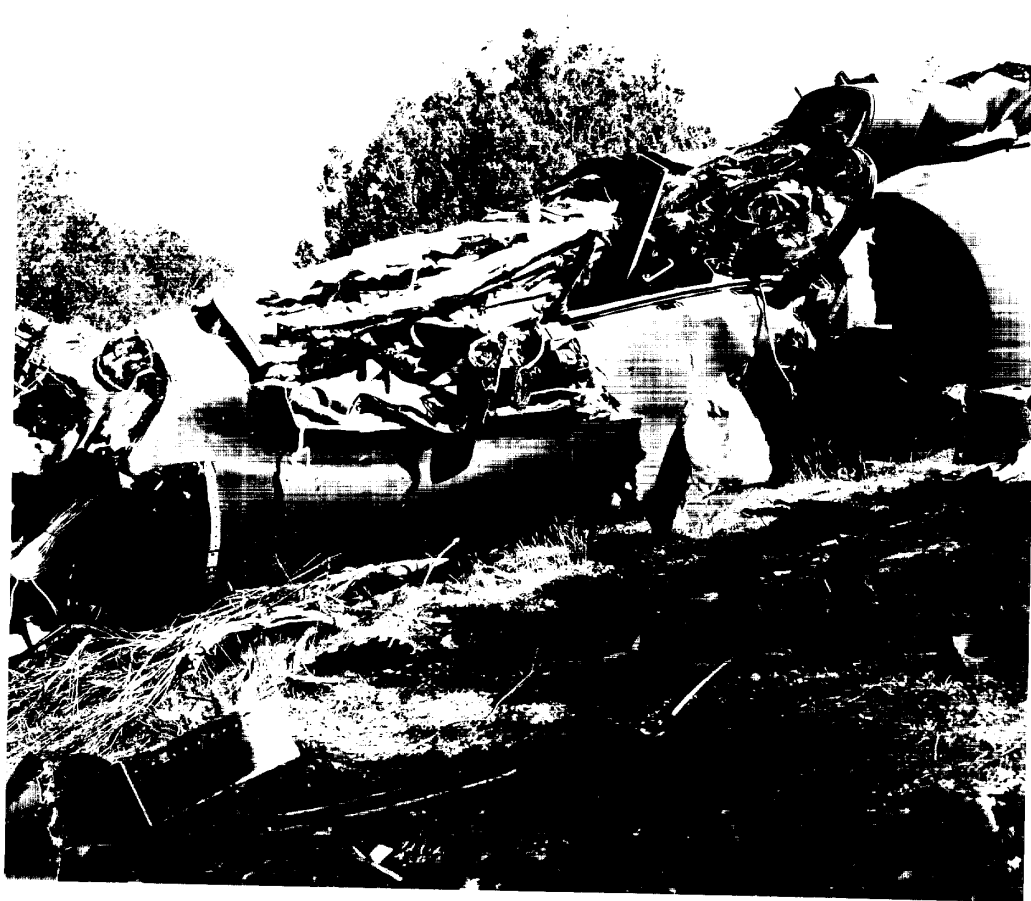
FORWARD FUSELAGE SHOWING COCKPIT AREA
